Builder Insight

Rainscreen Walls: Field Monitoring and Performance in Coastal British Columbia

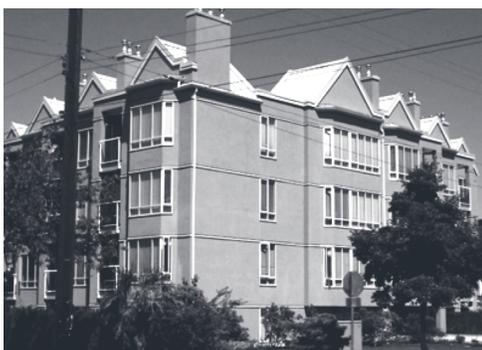
Typical four-storey, low-rise with rainscreen walls – BUILDING 2 OF THE MONITORING STUDY
Flashing at each floor level directs water from the air cavity to the exterior and allows ventilation

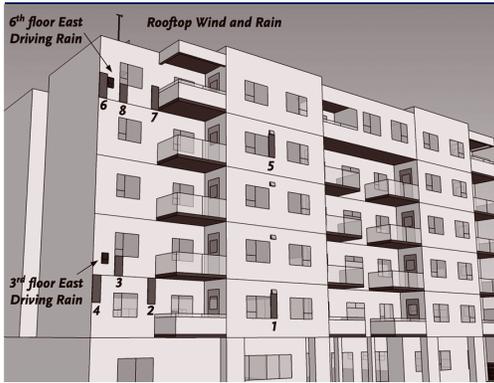
Eight monitored wall locations and weather sensors – BUILDING 3 OF THE MONITORING STUDY

For each building, the majority of the monitoring locations were chosen to represent areas most likely to be wetted during severe weather; e.g., on the east and south elevations at key details such as vents, windows, balcony transitions, and saddle flashings where historically, high moisture levels have been observed. Finally, locations were also selected away from details, to act as controls.

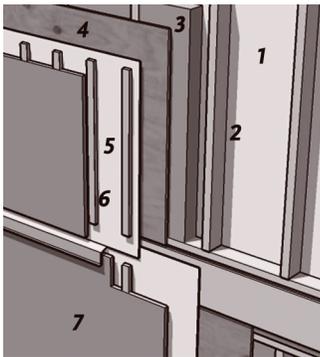
Generic woodframe stucco rainscreen wall assembly

- 1 Interior gypsum board and polyethylene vapour barrier
- 2 Wood framing
- 3 Fiberglass insulation
- 4 Plywood sheathing
- 5 Sheathing membrane
- 6 Wood strapping/air space
- 7 Stucco cladding on backer board

Figure 1 compares typical seasonal moisture content ranges for sheathing within a woodframe rainscreen wall in coastal BC (similar to that in the generic assembly shown). The black line plots typical measured values from the monitoring study. Normal, cautionary and dangerous ranges were developed from field measurements and computer modeling based

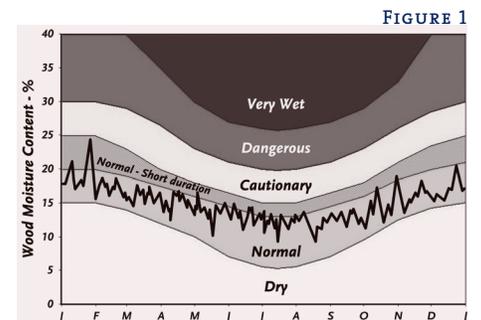
Seasonal moisture content ranges expected within woodframe rainscreen wall assemblies

During mild and rainy winter months, the sheathing behind rainscreen claddings will be exposed to RH levels of 80-100% for prolonged periods, which results in a moisture content of up to 20% (based on equilibrium conditions with the average RH). During prolonged rainy periods, it is normal for the sheathing moisture content to rise up to 25% for a few days when the cavity RH is sustained at 95-100% RH.

In the strapping or sheathing, a sustained (>1 month) moisture content of 20 to 30% indicates long-term exposure to high RH levels (>90%) within the rainscreen cavity. This could result from a rainwater leak into the cavity, condensation or poor cladding ventilation. A moisture content above approximately 28% (fibre saturation point of wood) is most likely the result of a rainwater leak directly contacting the affected sheathing or strapping and should be further investigated.

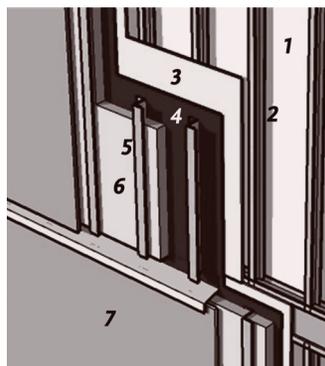
Exterior Insulated Rainscreen Wall Assembly of Building 5

- 1 Painted gypsum drywall
- 2 Steel stud framing (no insulation)
- 3 Exterior grade fibreglass faced gypsum
- 4 Self-adhered bituminous membrane
- 5 Steel Z-girts/air space
- 6 Rigid polystyrene insulation
- 7 Stucco cladding on backer board

The highly exposed, 30-storey high-rise building monitored was constructed with an exterior insulated wall assembly. This wall assembly consists of stucco cladding on backerboard over a ventilated and drained airspace, extruded polystyrene and a self-adhered air/vapour/water barrier membrane applied directly to fiberglass-faced gypsum sheathing. With the insulation outside the sheathing, moisture sensitive materials are kept warm

and dry, close to interior conditions. This rainscreen wall assembly proved most resistant to moisture from driving rain and exterior and interior humidity. All sensors in this building returned dry readings for the entire year. No evidence of exterior moisture penetration or condensation was observed at any of the monitored wall locations. Inward or outward vapour drive was not found to be an issue with the assembly.

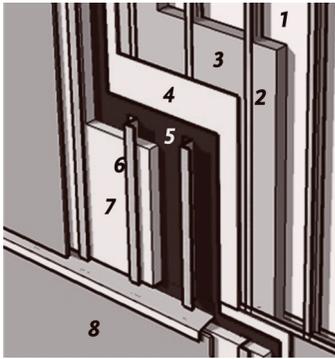
Split Insulated Rainscreen Wall Assembly of Building 3

- 1 Painted gypsum drywall
- 2 Steel stud framing
- 3 R-8 fiberglass batt insulation
- 4 Exterior grade fiberglass faced gypsum
- 5 Self-adhered bituminous membrane
- 6 Steel Z-girts/air space
- 7 Semi-rigid mineral wool insulation
- 8 Stucco cladding on backer board

Over several years, monitoring of this building showed seasonal elevated moisture conditions at all eight monitored locations. RH levels of greater than 90% (with peaks up to 100%) within the stud

space, and gypsum sheathing moisture contents greater than 1.5% (dangerous) were recorded from October to March every year. Field exploration confirmed the high readings and wet conditions within the wall.

Analysis of the wall assembly and boundary conditions determined that warm moist interior air leaking into the stud cavity and vapour diffusing through the painted interior gypsum resulted in the constant wetting observed. The distribution of insulation and location of vapour retarding layer (peel and stick) resulted in a wall assembly that was too sensitive to the interior conditions. Since reducing the permeability of the interior finishes would not adequately address the problem and could potentially introduce other problems, the building is currently undergoing a mechanical system retrofit to improve suite ventilation and to lower the wintertime RH.

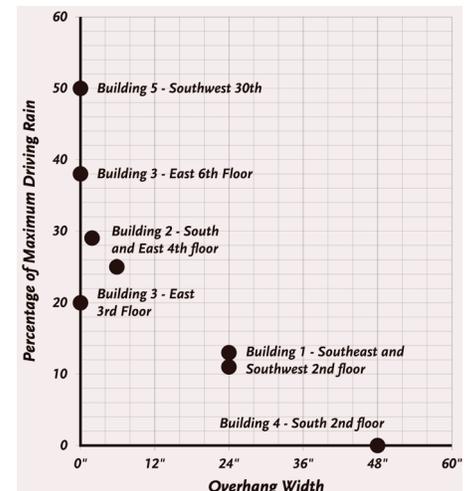
FIGURE 2

Roof overhang width versus measured percentage of driving rain potential

The five buildings in the study have varying roof overhang widths. Driving rain gauges placed on the vertical façade of the building enclosures provided some insight regarding the magnitude of the

While the annual rainfall amounts recorded were similar across all five buildings, wind speed differences, particularly at the four-storey buildings, account for the large differences in actual driving rainfall. Figure 2 compares the effect of roof overhang width versus driving rain accumulation at varying locations for all five monitored buildings. The measured driving rain is compared to the cumulative potential driving rain, based on horizontal rainfall, wind speed and wind direction measured at the roof. As shown, those buildings with large overhangs (24-48") received significantly less driving rain than those buildings with no overhang or overhangs less than 12". A 48" overhang on a relatively sheltered four-storey building can reduce driving rain on its façade to negligible levels. As anticipated, when overhangs are not present, upper floors received more driving rain than lower floors; however increased wetting from water cascading down over the lower wall areas is not shown by this figure. Taller buildings have greater wind-driven rain potential due to these wind spatial differences.
